**Flood Control Project Maintenance
Levee Inspections**
LMA District Cover Sheet
Spring 2019 Levee Inspection Results

Levee District No. 0001 (Glenn County)

Spring 2019 Levee Inspection Results

Waterway			Bank	Unit Miles
Unit No. 01 Sacramento River			Right	12.23
	Spring (March - May)	Summer (June - August)	(September - November) Fall	Winter (December - February)
Unit Maintenance Rating (Fall Only)				
Date of Inspection	4/26/2019 - 4/26/2019			
DWR Inspector	Makar Sokol			
Accompanied By	Nick Henning			
	Nick Perez

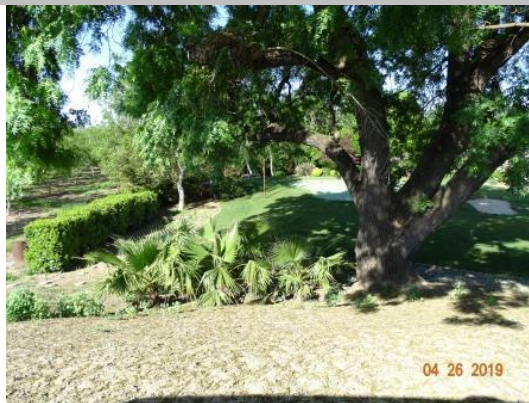
Photo 1 of 1 : SP_2019_LD0001G_432_53_20190429_00107.jpg

View of the palm trees at the landside toe. Spring 2019.

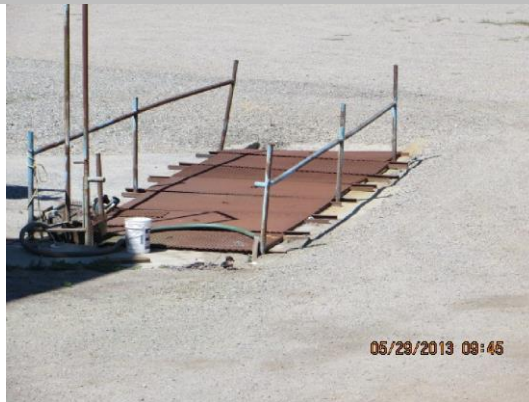
Photo 3 of 3 : UCIP_SP_2019_14324_23562.jpg

LM Start	0.77	Rating **	M	Issue No.	396 (cont)	
LM End	0.77	Issue Type +	En	Location *		
Category	Supplemental			GPS Latitude/Longitude		
				Start		End
Item	DWR UCIP Field Study			39.487806 °	39.487806 °	
				-122.019414 °	-122.019414 °	
DWR ID	22893					
Comment Code						
Inspector Comment						
FS_ID:14324 DS_ID:22893 EP_NO: 11782 Repair Type: Non-Urgent Crossing Status: Found UCIP Comments: 5/29/2013 - Siphon breaker missing from WS shoulder (W. Wylie - DWR UCIP) FIELD_STRUCT_DESC: 3-inch galvanized steel water pipe through the levee, 2 feet below the crown. There is a hose bib style siphon breaker on the waterside (WS) shoulder. A pipe runs from the concrete sump next to the barn on the landside (LS) to a cesspool off of the WS toe. (Permit No. 11782, 1976 - Carriere Brothers). [Additional Reference(s): DWR Levee Log, 1992]. FS Date: 5/29/2013

Concrete sump next to barn off LS toe.

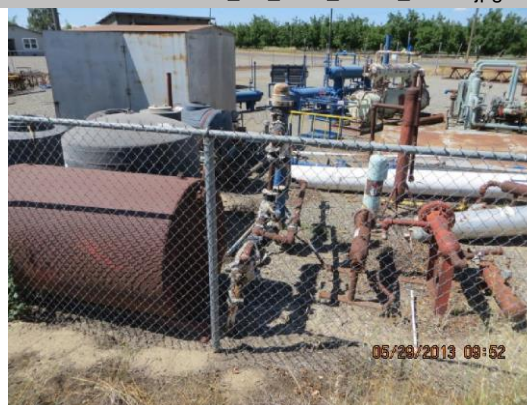
Photo 1 of 3 : UCIP_SP_2019_14325_23568.jpg

LM Start	0.80	Rating **	M	Issue No.	397
LM End	0.80	Issue Type +	En	Location *	
Category	Supplemental			GPS Latitude/Longitude	
				Start	End
Item	DWR UCIP Field Study			39.488160 °	39.488160 °
				-122.019888 °	-122.019888 °
DWR ID	22894				
Comment Code					
Inspector Comment					
FS_ID:14325 DS_ID:22894 EP_NO: 1837 Repair Type: Non-Urgent Crossing Status: Indicator Found UCIP Comments: 5/29/2013 - Gasline appears abandoned, need to verify abandonment or mark actual pipe location. (W. Wylie - DWR UCIP) FIELD_STRUCT_DESC: 3-inch gas pipeline of an unknown material through the levee, 2 feet below the crown. Fenced in pumping plant area next to levee with appurtenances. (Permit No. 1837, 1953 - Sunray Oil Corporation). [Additional Reference(s): DWR Levee Log, 1992]. FS Date: 5/29/2013

Gas pumping plant and appurtenances.

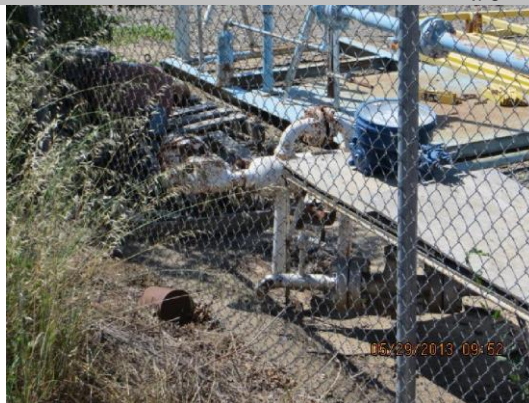
Photo 2 of 3 : UCIP_SP_2019_14325_23567.jpg

Possible pipe at crossing, LS toe.

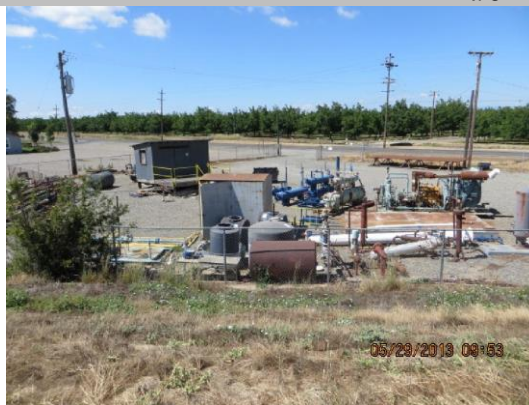
Photo 3 of 3 : UCIP_SP_2019_14325_23566.jpg

Gas pumping plant and appurtenances.

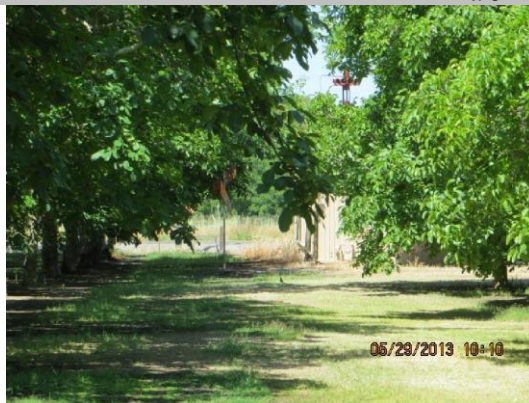
Photo 1 of 1 : UCIP_SP_2019_14327_23569.jpg

LM Start	1.25	Rating **	M	Issue No.	399	
LM End	1.25	Issue Type +	En	Location *		
Category	Supplemental			GPS Latitude/Longitude		
				Start	End	
Item	DWR UCIP Field Study			39.493977 °	39.493977 °	
				-122.018380 °	-122.018380 °	
DWR ID	22896					
Comment Code						
Inspector Comment						
FS_ID:14327 DS_ID:22896 EP_NO: 2171 Repair Type: Non-Urgent Crossing Status: Indicator Found UCIP Comments: Appears abandoned as well off LS toe has been removed. Need to remove from levee or mark as appropriate. FIELD_STRUCT_DESC: 2 of 2: 3-inch gas pipeline of an unknown material through the levee, 2 feet below the crown. Abandoned gas pumping station 260 feet off the landside (LS) toe. (Permit No. 2171, 1955 - Sunray Mid-Continent Oil Company). [Additional Reference(s): DWR Levee Log, 1992]. FS Date: 5/29/2013

Gasline markers near where removed pumping plant was located.

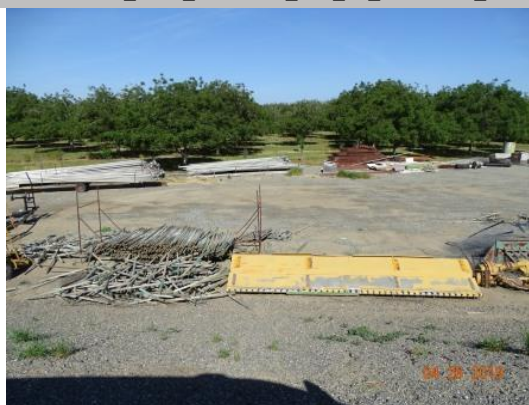
Photo 1 of 1 : SP_2019_LD0001G_432_71_20190429_00108.jpg

View of the farm equipment and materials at the landside toe. Spring 2019.

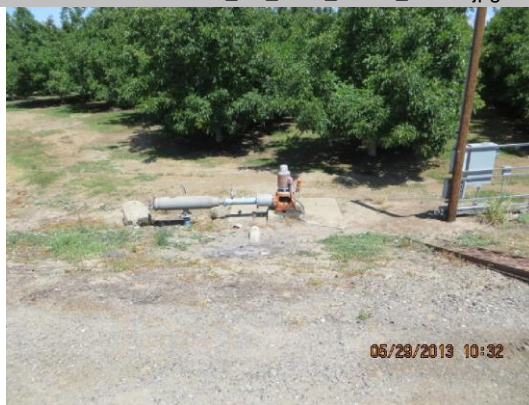
Photo 1 of 2 : UCIP_SP_2019_14331_23579.jpg

LM Start	2.22	Rating **	M	Issue No.	401
LM End	2.22	Issue Type +	En	Location *	
Category	Supplemental			GPS Latitude/Longitude	
				Start	End
Item	DWR UCIP Field Study			39.501690 °	39.501690 °
				-122.006100 °	-122.006100 °
DWR ID	22898				
Comment Code					
Inspector Comment					
FS_ID:14331					
DS_ID:22898					
EP_NO: 5717A					
Repair Type: Non-Urgent					
Crossing Status: Found					
UCIP Comments: Pipe abandoned and should be done so properly.					
FIELD_STRUCT_DESC: 8-inch asbestos cement irrigation pipe sleeved through a 12-inch pipe through the levee, 5 feet below the crown. Pump located on the landside (LS). Meter pole located on the LS toe. Guy wire anchor in LS slope. (Permit No. 5717-A, 1969 - W. A. Carriere).					
[Additional Reference(s): DWR Levee Log, 1992].					
FS Date: 5/29/2013

Pump at LS toe with no connection to 8-inch pipe.

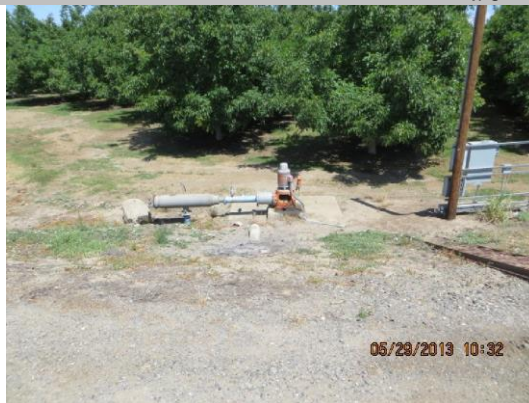
Photo 1 of 3 : UCIP_SP_2019_14332_23582.jpg

LM Start	2.22	Rating **	M	Issue No.	402
LM End	2.22	Issue Type +	Ma	Location *	
Category	Supplemental			GPS Latitude/Longitude	
				Start	End
Item	DWR UCIP LMA Responsibility			39.501690 °	39.501690 °
				-122.006099 °	-122.006099 °
DWR ID	22944				
Comment Code					
Inspector Comment					
FS_ID:14332 DS_ID:22944 EP_NO: N/A Repair Type: Non-Urgent Crossing Status: Found UCIP Comments: Appears abandoned and should be done so properly. FIELD_STRUCT_DESC: *ABANDONED* 8-inch drainage pipe of an unknown material sleeved through a 12-inch pipe of an unknown material through the levee, 9.5 feet below the crown. Flap gate located on the waterside (WS). Pipe open on the landside (LS). [Additional Reference(s): USACE Sacramento O&M Manual 140, May 1960, (HLM 2.27)]. FS Date: 5/29/2013

Pump at location of pipe on LS toe.

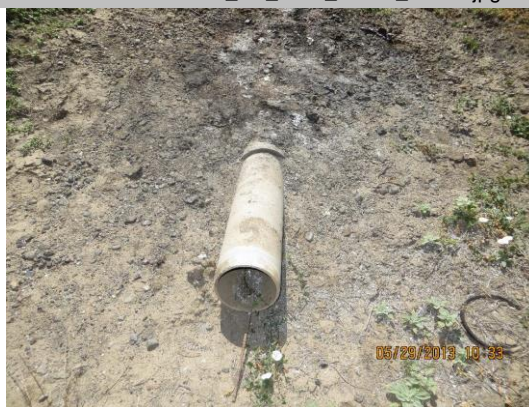
Photo 3 of 3 : UCIP_SP_2019_14332_23580.jpg

8-inch pipe sleeved through a 12-inch concrete pipe.

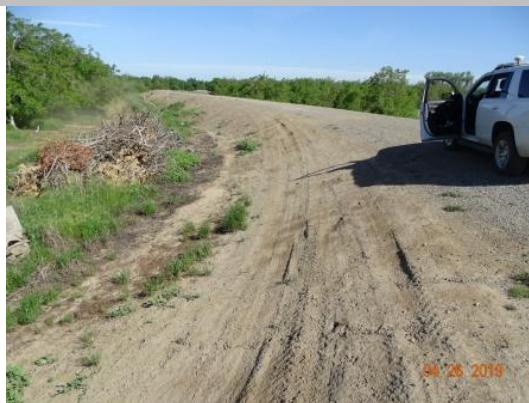
Photo 1 of 1 : SP_2019_LD0001G_432_77_20190429_00109.jpg

LM Start	3.04	Rating **	M	Issue No.	77
LM End	3.04	Issue Type +	Ma	Location *	LS
Category	Earthen Levee			GPS Latitude/Longitude	
				Start	End
Item	Slope Stability			39.512932 °	39.512932 °
				-122.009074 °	-122.009074 °
DWR ID	DWR_LD0001G_01_s_2019_77				
Comment Code					
S3 : Repair the levee slope damaged by vehicle traffic and prevent access where possible.					
Inspector Comment

View of the landside slope damaged by vehicle traffic. Spring 2019.

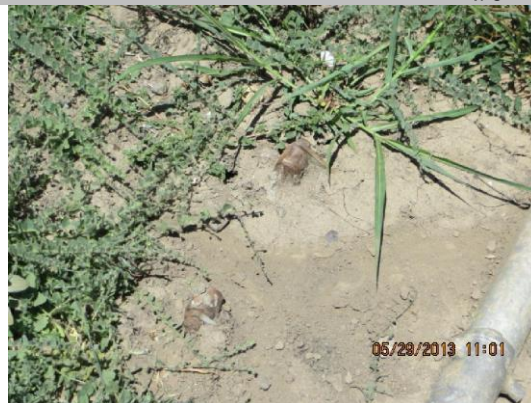
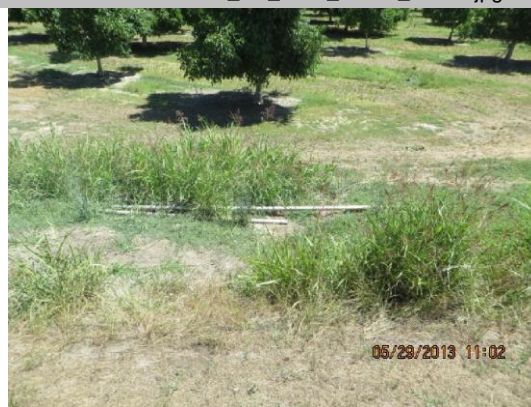
LM Start	3.13	Rating **	M	Issue No.	403
LM End	3.13	Issue Type +	En	Location *	
Category	Supplemental			GPS Latitude/Longitude	
				Start	End
Item	DWR UCIP Field Study			39.513835 °	39.513835 °
				-122.010029 °	-122.010029 °
DWR ID	22901				
Comment Code					
Inspector Comment					
FS_ID:16223 DS_ID:22901 EP_NO: 9575 Repair Type: Non-Urgent Crossing Status: Found UCIP Comments: Appears to have been abandoned. Need to verify pipe was grouted/abandoned properly. FIELD_STRUCT_DESC: *ABANDONED* 12-inch drainage pipe of an unknown material through the levee, 14 feet below the crown. Flap Gate on the waterside (WS) end. (Automatic Board Order (ABO) issued as Permit No. 9575, 1974 - Franklin Emmett, Bette Lou Dillard Jr., and McIntyre). [Additional Reference(s): DWR Levee Log, 1992]. FS Date: 5/29/2013

Flap gate visible at WS toe.

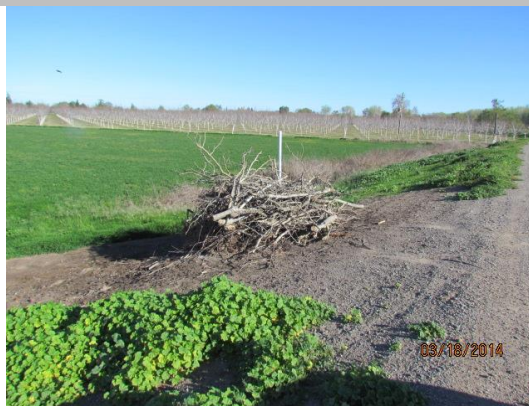
Photo 1 of 1 : SP_2019_LD0001G_432_46_20190313_00013.jpg

View of the prunings along the landside slope.

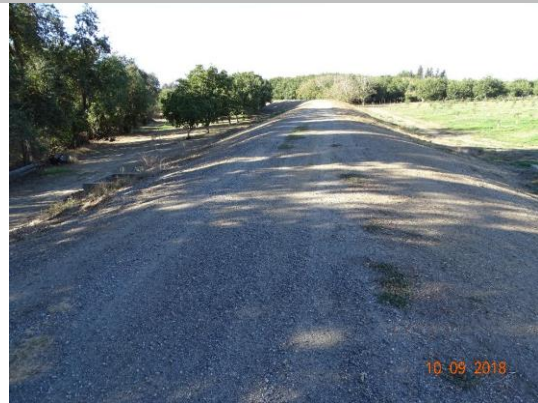
Photo 1 of 3 : UCIP_SP_2019_53006_78123.jpg

Comment Code					
Inspector Comment					
FS_ID:53006 DS_ID:22904 EP_NO: 9572 Repair Type: Urgent Crossing Status: Found UCIP Comments: 10/9/2018 No change to the crossing status. Flap gate on WS cannot be fully closed due to a 3-inch pipe through drainage pipe crossing the levee. Water is supplied from a well on LS via 3-inch pipe to the WS for irrigation/drinking purposes. Owner will need to remove obstruction to allow proper flap gate closure. (O.Yakimov - DWR)12/21/2016 Flap gate on WS does not appear to be broken however, flap gate does not fully close due to a 3-inch aluminum pipe sleeve through larger pipe. Need to remove 3-inch pipe in order to have WS flap gate close and to be compliant with Title 23. (O. Magana - DWR UCIP)05/29/2013 Broken flap gate and Concrete headwall on LS toe possibly tilting. Also a 3-inch alluminum irrigation line through the pipe. (W. Wylie - DWR UCIP) FIELD_STRUCT_DESC: 18-inch steel drainage pipe through the levee, 7.3 feet below the crown. Flap gate in 6-inch by 6-inch concrete box located on the waterside (WS) end. Concrete headwall located on the landside (LS) toe. (18-inch pipe [HLM 4.05] authorized under Automatic Board Order (ABO) issued as Permit No. 9572, 1974 - Henry and Annabel B. Smith). [Additional Reference(s): DWR Levee Log, 1992. USACE Sacramento O&M Manual 140, May 1960, (HLM 4.05)]. FS Date: 10/9/2018 3:27:06 PM

View of levee crown at the crossing.

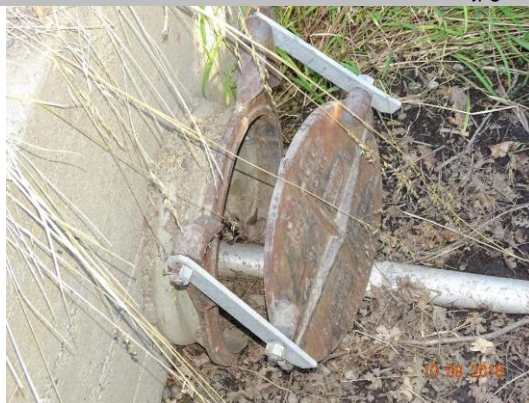
Photo 3 of 3 : UCIP_SP_2019_53006_78125.jpg

Comment Code						
Inspector Comment						
FS_ID:53006 DS_ID:22904 EP_NO: 9572 Repair Type: Urgent Crossing Status: Found UCIP Comments: 10/9/2018 No change to the crossing status. Flap gate on WS cannot be fully closed due to a 3-inch pipe through drainage pipe crossing the levee. Water is supplied from a well on LS via 3-inch pipe to the WS for irrigation/drinking purposes. Owner will need to remove obstruction to allow proper flap gate closure. (O.Yakimov - DWR)12/21/2016 Flap gate on WS does not appear to be broken however, flap gate does not fully close due to a 3-inch aluminum pipe sleeve through larger pipe. Need to remove 3-inch pipe in order to have WS flap gate close and to be compliant with Title 23. (O. Magana - DWR UCIP)05/29/2013 Broken flap gate and Concrete headwall on LS toe possibly tilting. Also a 3-inch alluminum irrigation line through the pipe. (W. Wylie - DWR UCIP) FIELD_STRUCT_DESC: 18-inch steel drainage pipe through the levee, 7.3 feet below the crown. Flap gate in 6-inch by 6-inch concrete box located on the waterside (WS) end. Concrete headwall located on the landside (LS) toe. (18-inch pipe [HLM 4.05] authorized under Automatic Board Order (ABO) issued as Permit No. 9572, 1974 - Henry and Annabel B. Smith). [Additional Reference(s): DWR Levee Log, 1992. USACE Sacramento O&M Manual 140, May 1960, (HLM 4.05)]. FS Date: 10/9/2018 3:27:06 PM

3-inch pipe obstructs flap gate from complete closing.

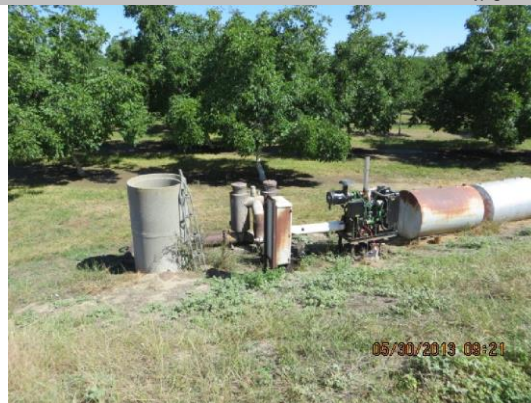
Photo 1 of 3 : UCIP_SP_2019_51284_23594.jpg

Comment Code					
Inspector Comment					
FS_ID:51284 DS_ID:22906 EP_NO: 1229 Repair Type: Non-Urgent Crossing Status: Found UCIP Comments: 12/21/2016 same as last inspection. Crossing has been modified from original permit. Need to contact owner to determine permit number issued for modification and to determine current status of crossing. Crossing has been downgraded from Urgent to Non-Urgent due to no damage observed on levee slopes or crown. (O. Magana - DWR UCIP)05/30/2013 Gate valve broken off in concrete standpipe on WS shoulder. 8-inch aluminum pipe sleeved through pipe prevents closure of 18-inch pipe. All concrete standpipes have been modified or broken. (W. Wylie - DWR UCIP) FIELD_STRUCT_DESC: 16-inch concrete (not 18-inch asphalt dipped steel as referenced in permit or USACE O&M manual) irrigation pipe through the levee, 8.6 feet below the crown. Gate valve in concrete well located on the waterside (WS) slope. Pump, service pole, engine, and fuel tank 48-inch, and standpipe are located on the toe of the landside (LS) slope (Permit No. 1229, 1947 - R. T. Miller). [Additional Reference(s): DWR Levee Log, 1992. USACE Sacramento O&M Manual Unit 140, May 1960, (HLM 4.33)]. FS Date: 12/21/2016

Pump, standpipe, and gate valve on LS toe.

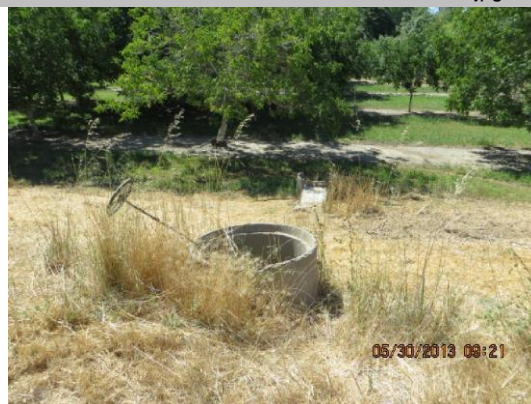
Photo 2 of 3 : UCIP_SP_2019_51284_23593.jpg

Gate valve in Concrete riser on WSs houlder.

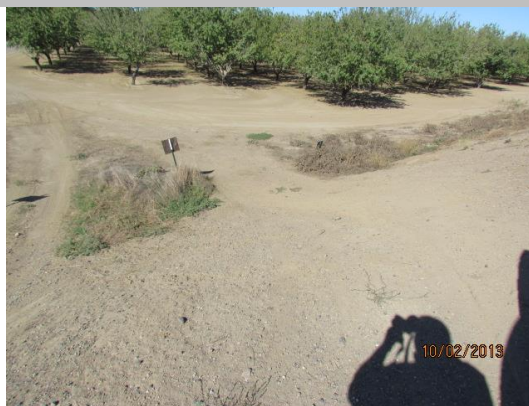
Photo 1 of 1 : SP_2019_LD0001G_432_57_20190313_00019.jpg

LM Start	5.06	Rating **	M	Issue No.	57
LM End	5.06	Issue Type +	Ma	Location *	LS
Category	Earthen Levee			GPS Latitude/Longitude	
				Start	End
Item	Slope Stability			39.534593 °	39.534593 °
				-121.995950 °	-121.995950 °
DWR ID	DWR_LD0001G_01_f_2013_57				
Comment Code					
S3 : Repair the levee slope damaged by vehicle traffic and prevent access where possible.					
Inspector Comment

View of the vehicle erosion along the slope of the levee.

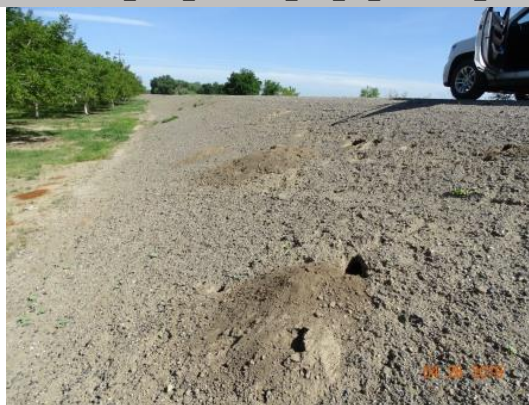
Photo 1 of 1 : SP_2019_LD0001G_432_82_20190429_00110.jpg

View of the rodent activity on the landside slope. Spring 2019.

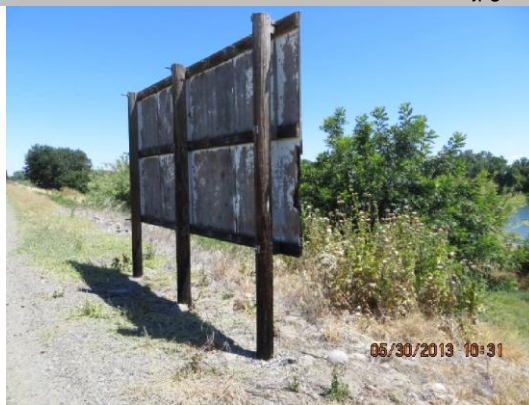
Photo 2 of 2 : UCIP_SP_2019_14352_23608.jpg

Gasline sign on WS shoulder.

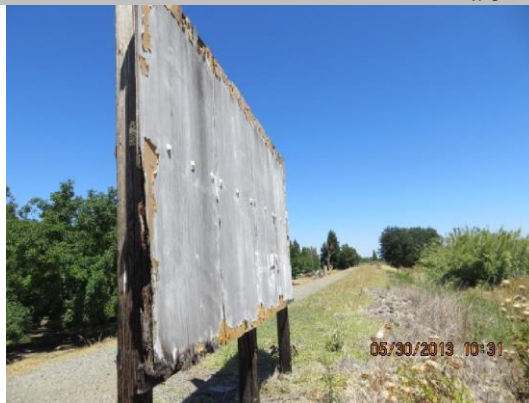
Photo 1 of 1 : UCIP_SP_2019_16224_27345.jpg

Gasline sign on WS shoulder.

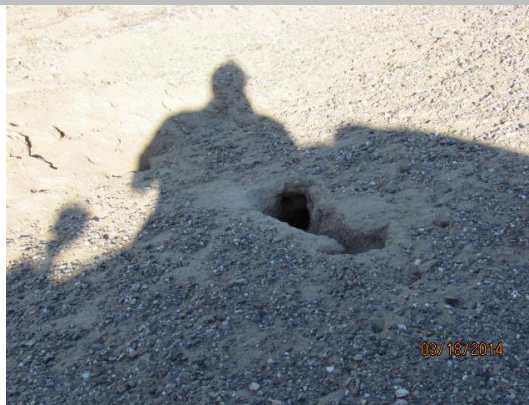
Photo 1 of 1 : SP_2019_LD0001G_432_47_20190313_00014.jpg

View of the rodent activity along the LS slope.

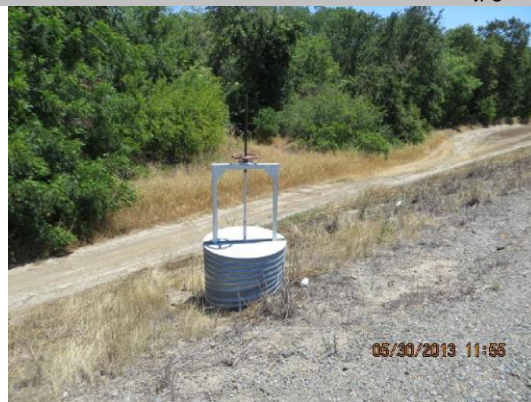
Photo 2 of 3 : UCIP_SP_2019_14384_23663.jpg

Slide gate in 36-inch CMP standpipe on WS slope

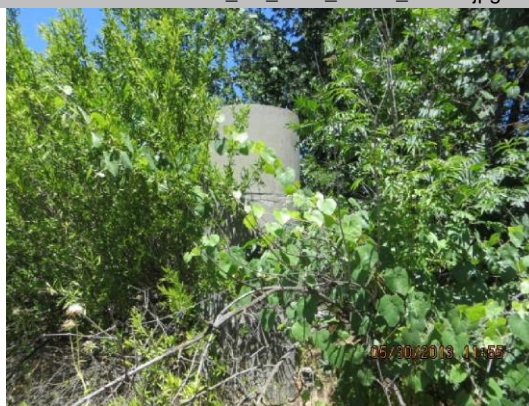
Photo 3 of 3 : UCIP_SP_2019_14384_23662.jpg

Concrete standpipe off WS toe.

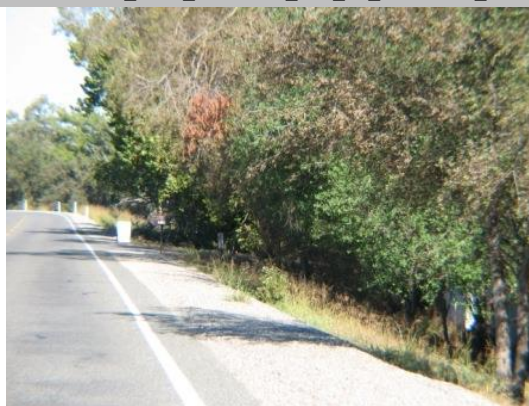
Photo 1 of 1 : SP_2019_LD0001G_432_20_20190313_00008.jpg

View of the trees and vegetation along the waterside slope of the levee.

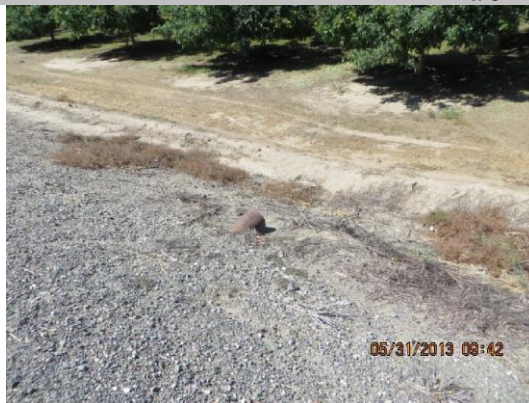
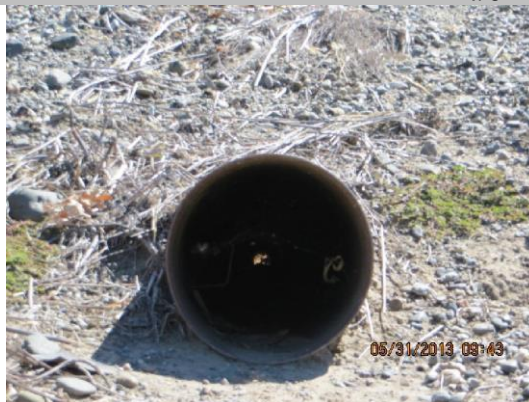
Pipe on LS slope.

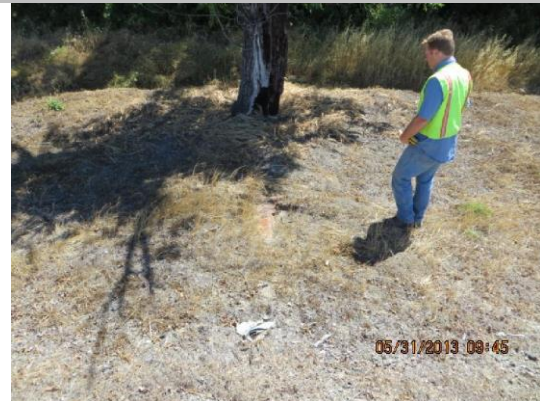
Photo 3 of 3 : UCIP_SP_2019_53341_23666.jpg

Pipe on WS slope.

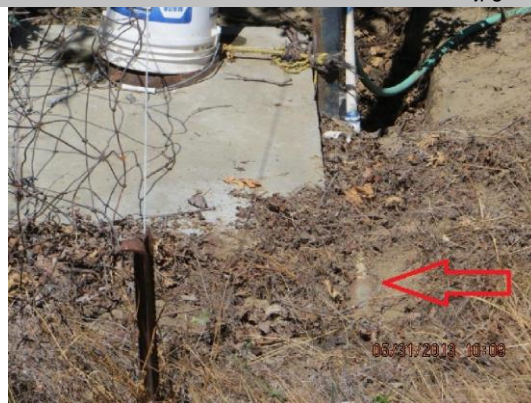
Photo 2 of 3 : UCIP_SP_2019_16204_27329.jpg

Pipe visible next to well with bucket over standpipe.

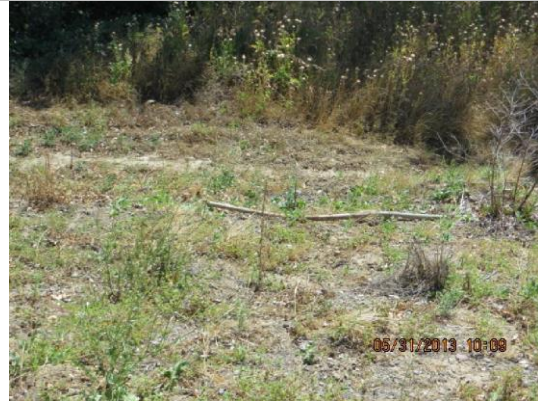
Photo 3 of 3 : UCIP_SP_2019_16204_27328.jpg

Pipe debris on WS slope may be indicator of pipe location on WS.

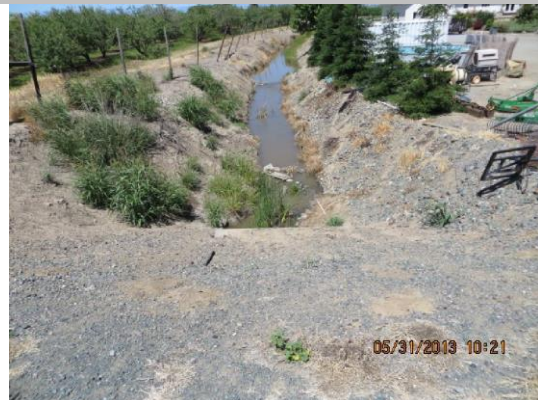
Photo 1 of 3 : UCIP_SP_2019_14389_23686.jpg

Pipe and headwall at LS toe.

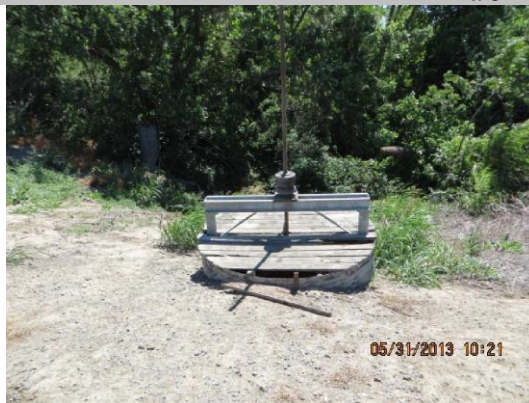
Photo 2 of 3 : UCIP_SP_2019_14389_23685.jpg

Slide gate in 8-foot diameter CMP riser on WS slope.

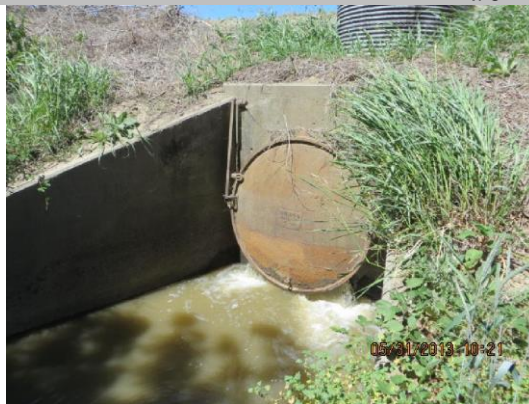
Photo 3 of 3 : UCIP_SP_2019_14389_23684.jpg

Flap gate and headwall on WS toe.

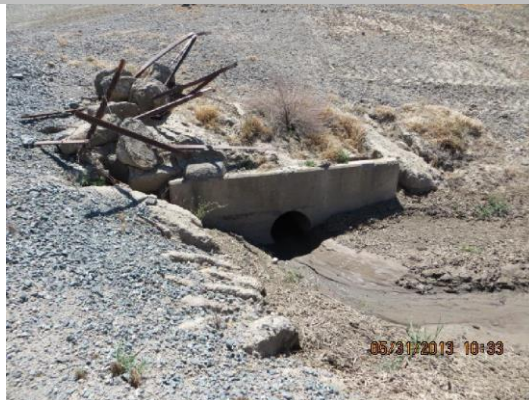
Photo 2 of 3 : UCIP_SP_2019_14390_23689.jpg

Concrete headwall and pipe at LS toe.

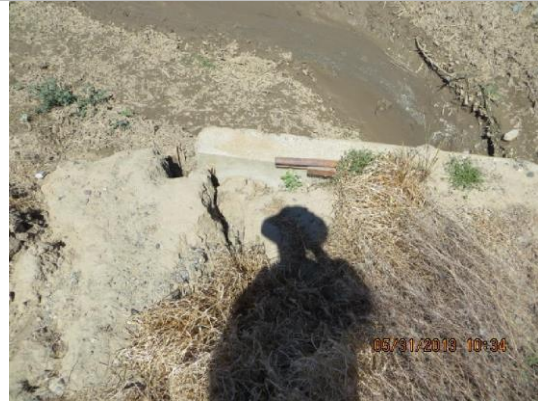
Photo 3 of 3 : UCIP_SP_2019_14390_23688.jpg

Erosion around headwall at LS toe.

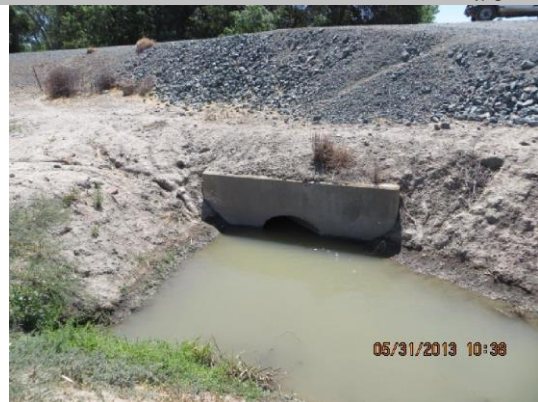
Photo 1 of 3 : UCIP_SP_2019_14559_23986.jpg

Pipe and headwall on LS toe.

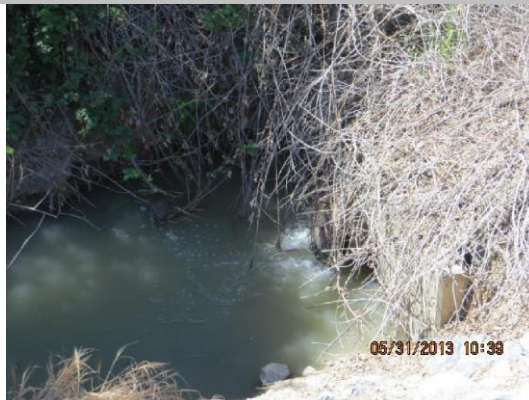
Photo 3 of 3 : UCIP_SP_2019_14559_23984.jpg

Pipe, flapgate, and headwall on WS toe.

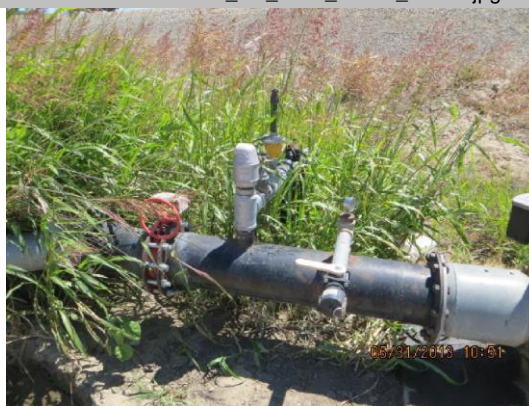
Photo 1 of 3 : UCIP_SP_2019_16205_27333.jpg

Pump with siphon breaker, vent and filter on LS toe.

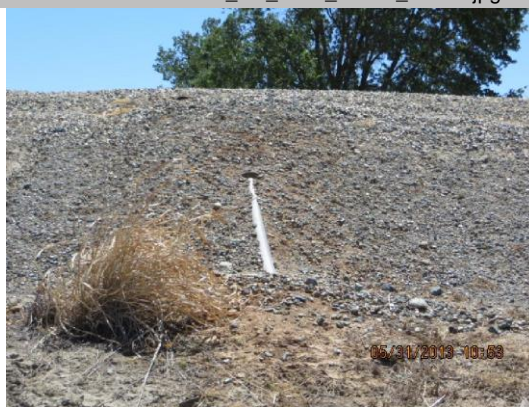
Photo 2 of 3 : UCIP_SP_2019_16205_27332.jpg

Pipe on LS slope.

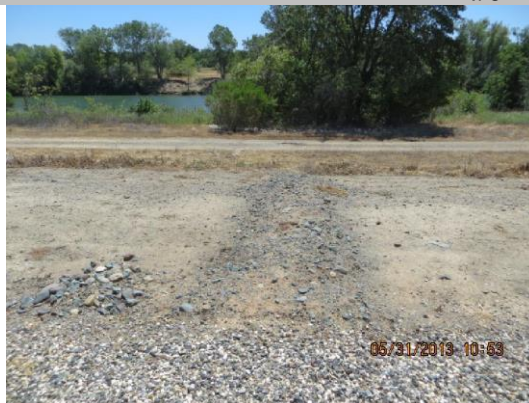
Photo 3 of 3 : UCIP_SP_2019_16205_27331.jpg

Cover over pipe on WS berm.

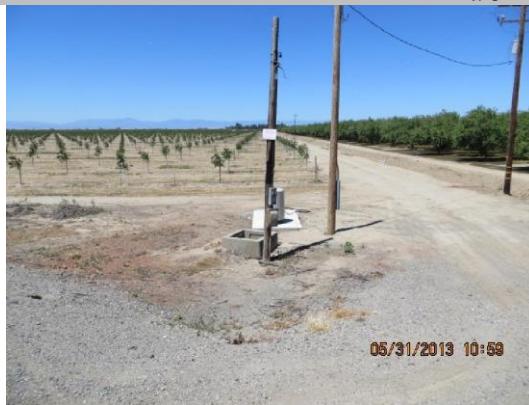
Photo 1 of 3 : UCIP_SP_2019_14561_23989.jpg

Concrete distribution box at LS toe.

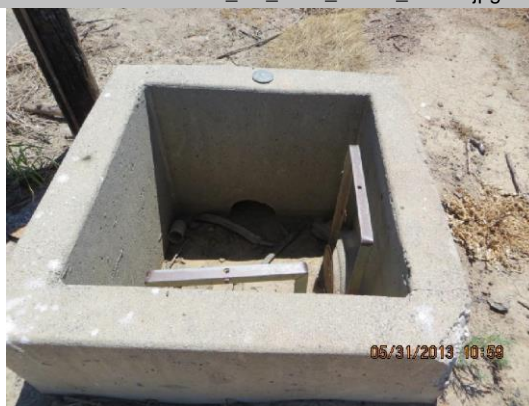
Photo 2 of 3 : UCIP_SP_2019_14561_23988.jpg

Concrete distribution box at LS toe with outlet from pipe through levee.

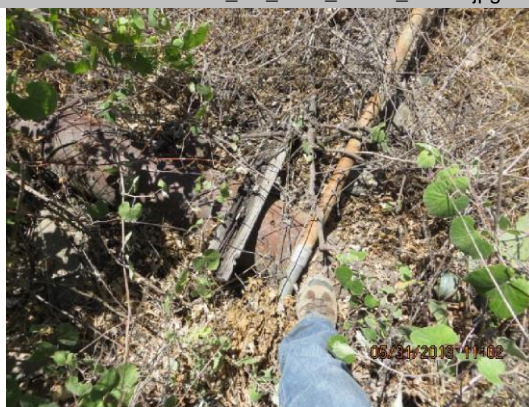
Photo 3 of 3 : UCIP_SP_2019_14561_23987.jpg

10-inch steel pipe and 1.5-inch electrical conduit on WS slope.

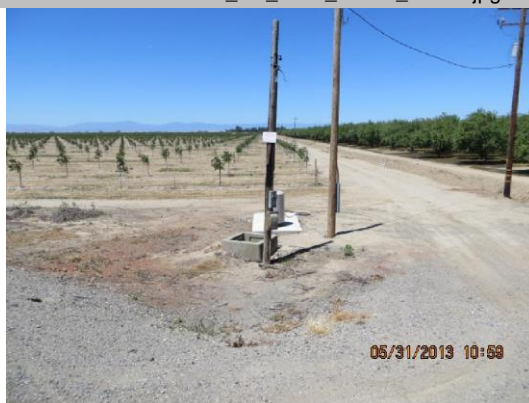
Photo 1 of 2 : UCIP_SP_2019_14562_23991.jpg

Source at JP next to concrete distribution box at LS toe.

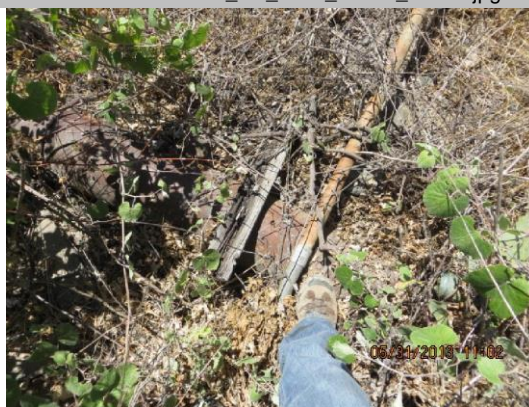
Photo 2 of 2 : UCIP_SP_2019_14562_23990.jpg

Pipe visible off WS toe.

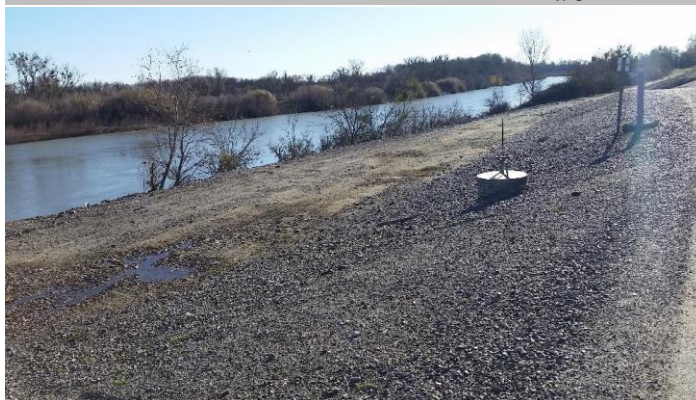
Photo 1 of 3 : UCIP_SP_2019_53340_76411.jpg

View of WS.

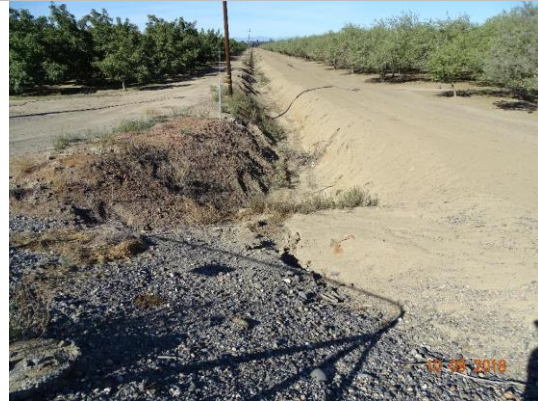
Photo 3 of 3 : UCIP_SP_2019_53340_78136.jpg

Drainage channel on LS.

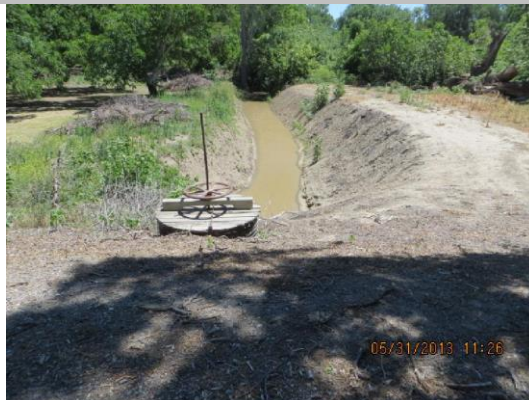
Photo 2 of 3 : UCIP_SP_2019_14565_24008.jpg

Slide gate in 60-inch CMP riser on WS slope.

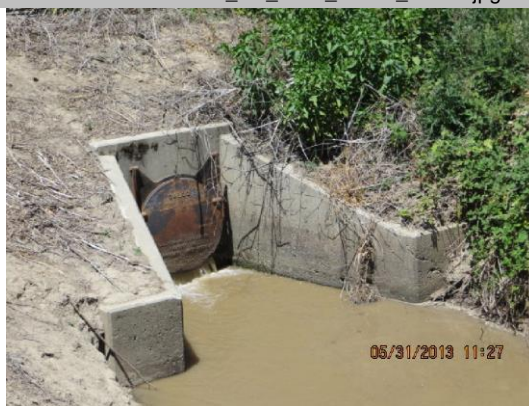
Photo 3 of 3 : UCIP_SP_2019_14565_24007.jpg

Flap gate and concrete headwall on WS toe.

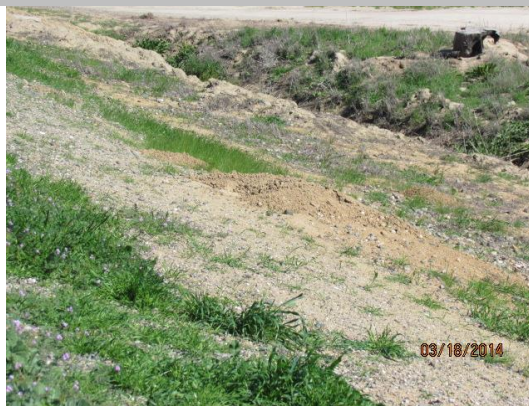
Photo 1 of 1 : SP_2019_LD0001G_432_48_20190313_00015.jpg

View of the rodent activity along the waterside slope.

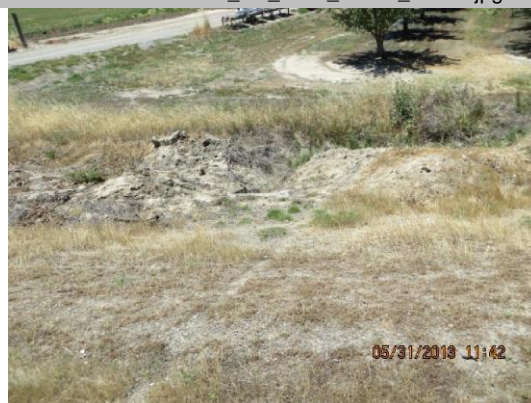
Photo 1 of 3 : UCIP_SP_2019_14566_24013.jpg

Concrete headwall on LS toe.

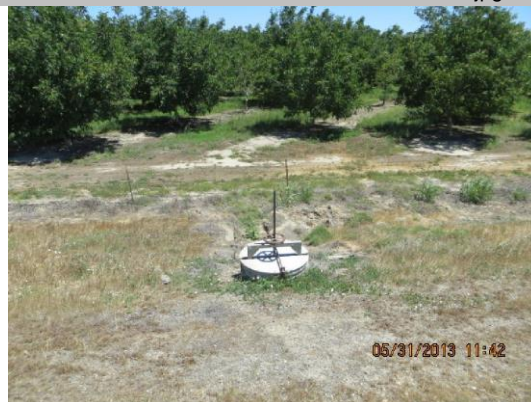
Photo 2 of 3 : UCIP_SP_2019_14566_24012.jpg

Slide gate in 36-inch CMP riser on WS slope.

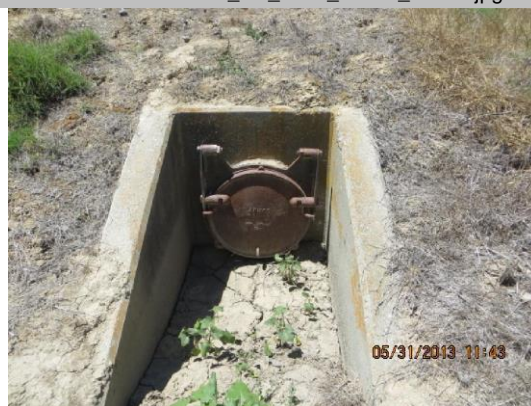
Photo 3 of 3 : UCIP_SP_2019_14566_24011.jpg

Concrete headwall and flapgate on WS toe

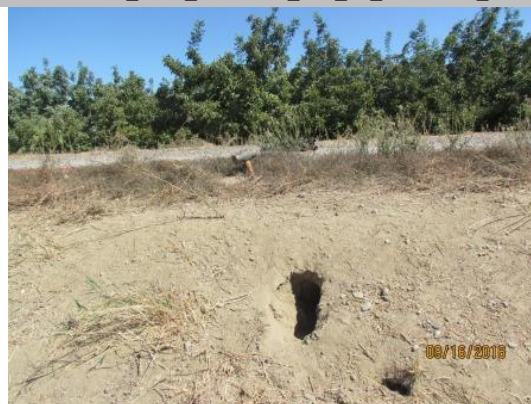
Photo 1 of 2 : SP_2019_LD0001G_432_79_20190313_00033.jpg

View of the rodent holes along the landside slope with large hammer sitting in the hole.

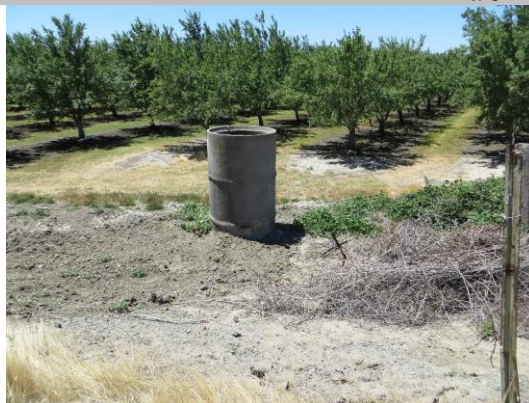
Photo 1 of 3 : UCIP_SP_2019_14567_24017.jpg

Concrete standpipe on LS toe.

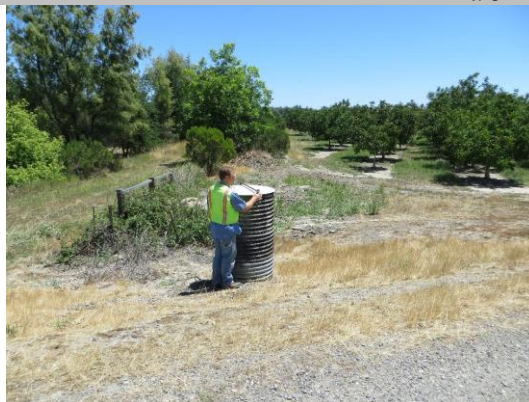
Photo 2 of 3 : UCIP_SP_2019_14567_24016.jpg

Slide gate in CMP riser on WS toe.

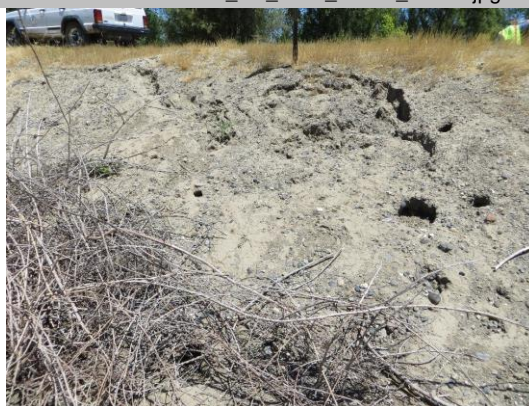
Photo 3 of 3 : UCIP_SP_2019_14567_24015.jpg

Erosion and sloughing on LS slope possibly due to rodent activity.

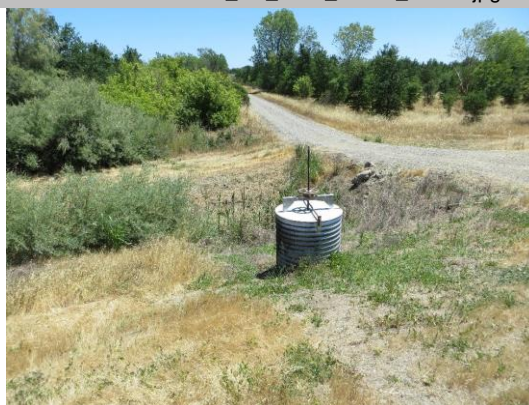
Photo 1 of 3 : UCIP_SP_2019_14569_24026.jpg

Slidegate in 36-inch CMP riser on WS slope.

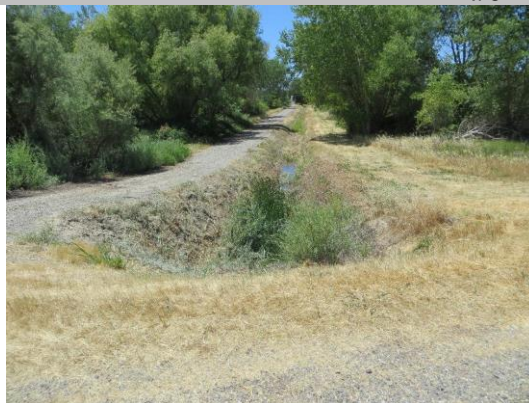
Photo 2 of 3 : UCIP_SP_2019_14569_24025.jpg

Drainage channel on LS toe.

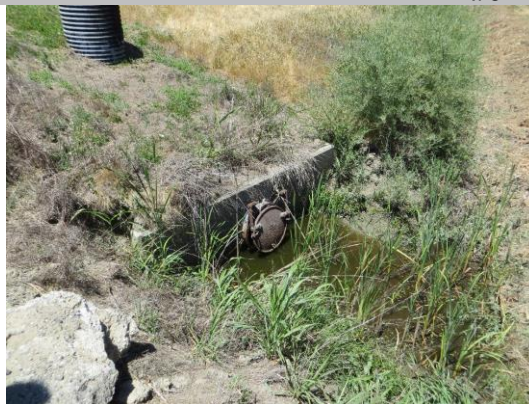
Photo 3 of 3 : UCIP_SP_2019_14569_24024.jpg

Headwall and flapgate on WS toe.

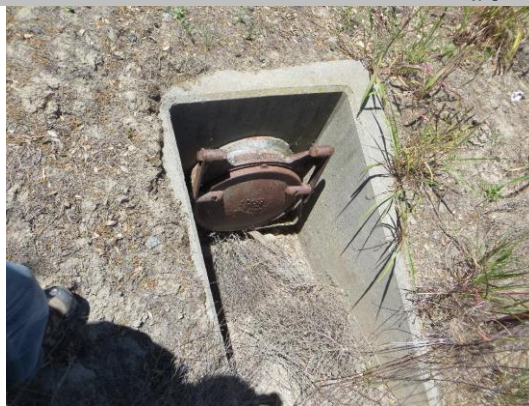
Photo 1 of 3 : UCIP_SP_2019_14570_24029.jpg

Flapgate and U-shaped concrete headwall on WS toe.

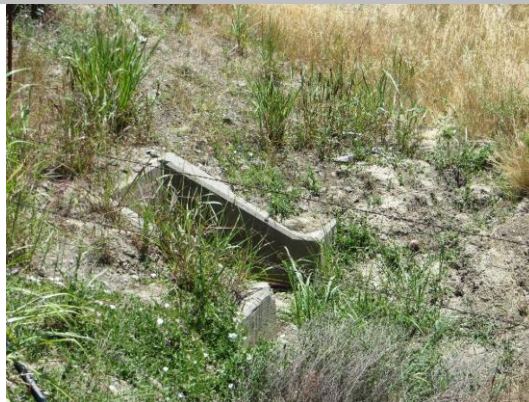
Photo 3 of 3 : UCIP_SP_2019_14570_24027.jpg

U-shaped concrete headwall on LS toe.
